The Carningli Mountain Railway and stone quarry

THE SAD TALE OF THE CARNINGLI MOUNTAIN RAILWAY

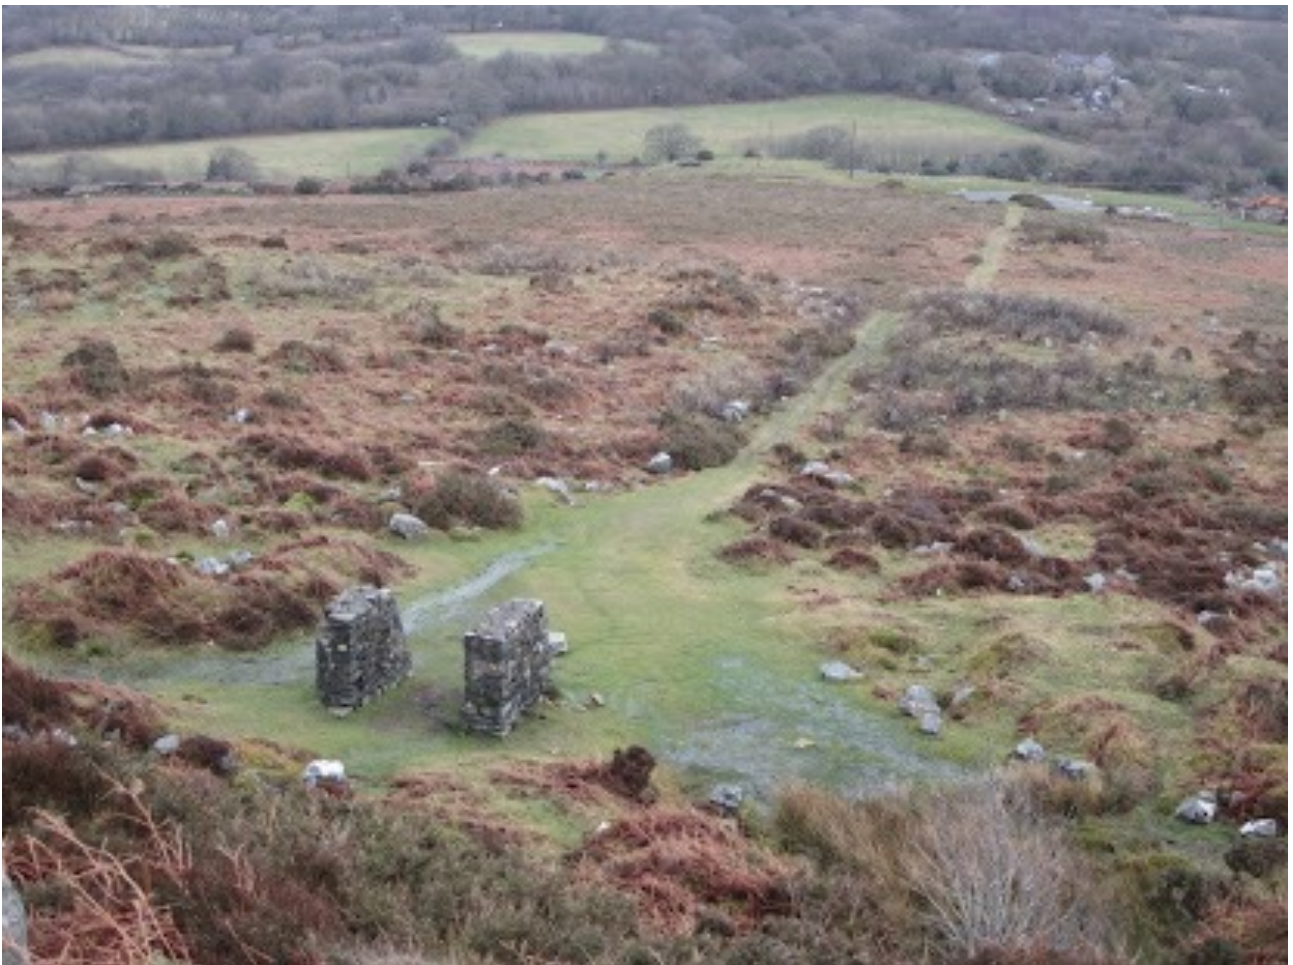
The incline running down from the cable drum pillars (the "Gateway to Carningli") bottom left. The quarried area was mostly to the right, off the picture.

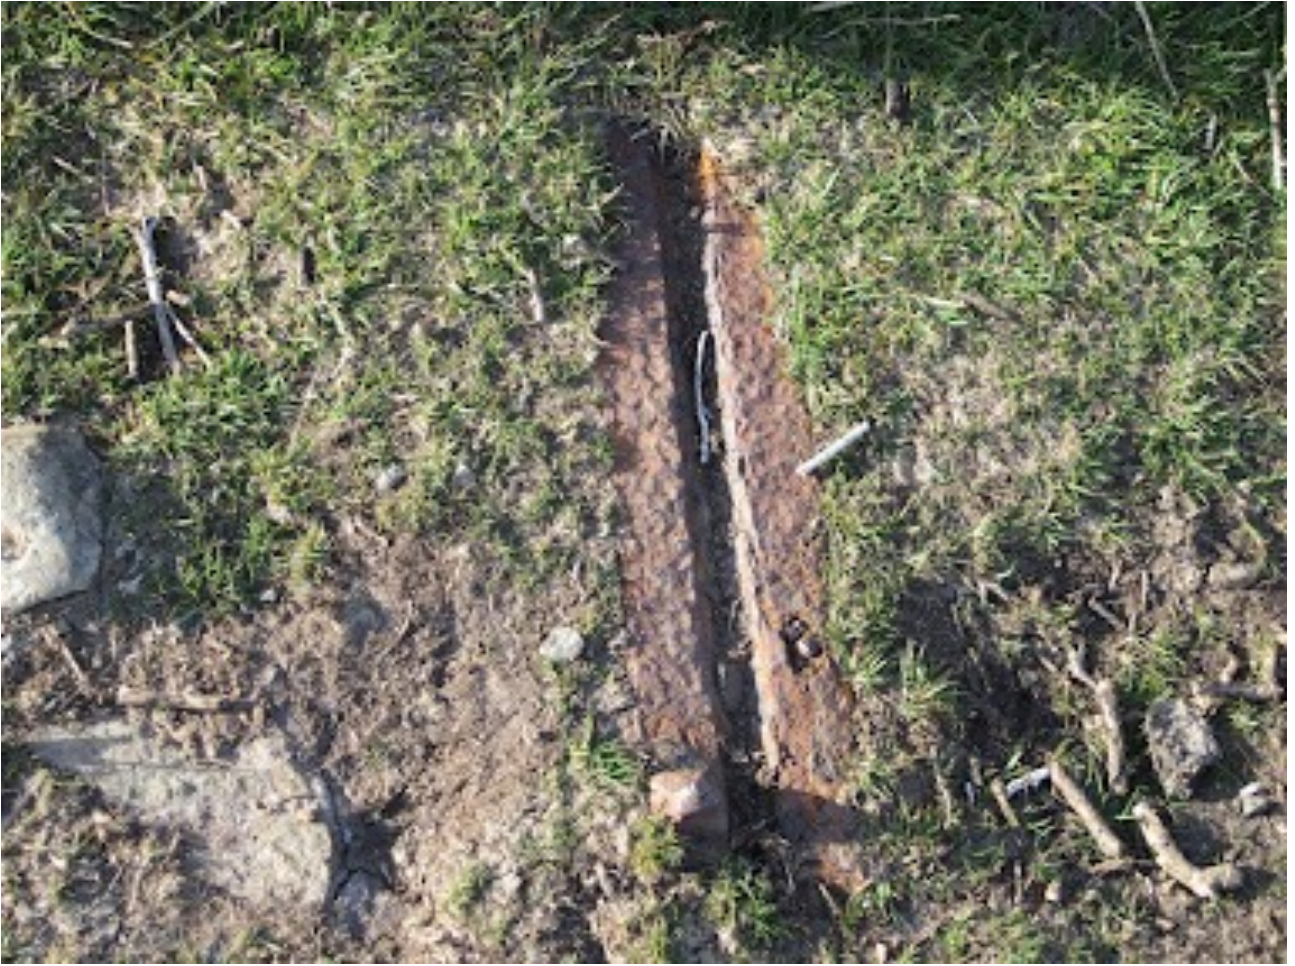
One of the iron sleepers exposed on the incline. This was just a section of iron rail, placed upside down.

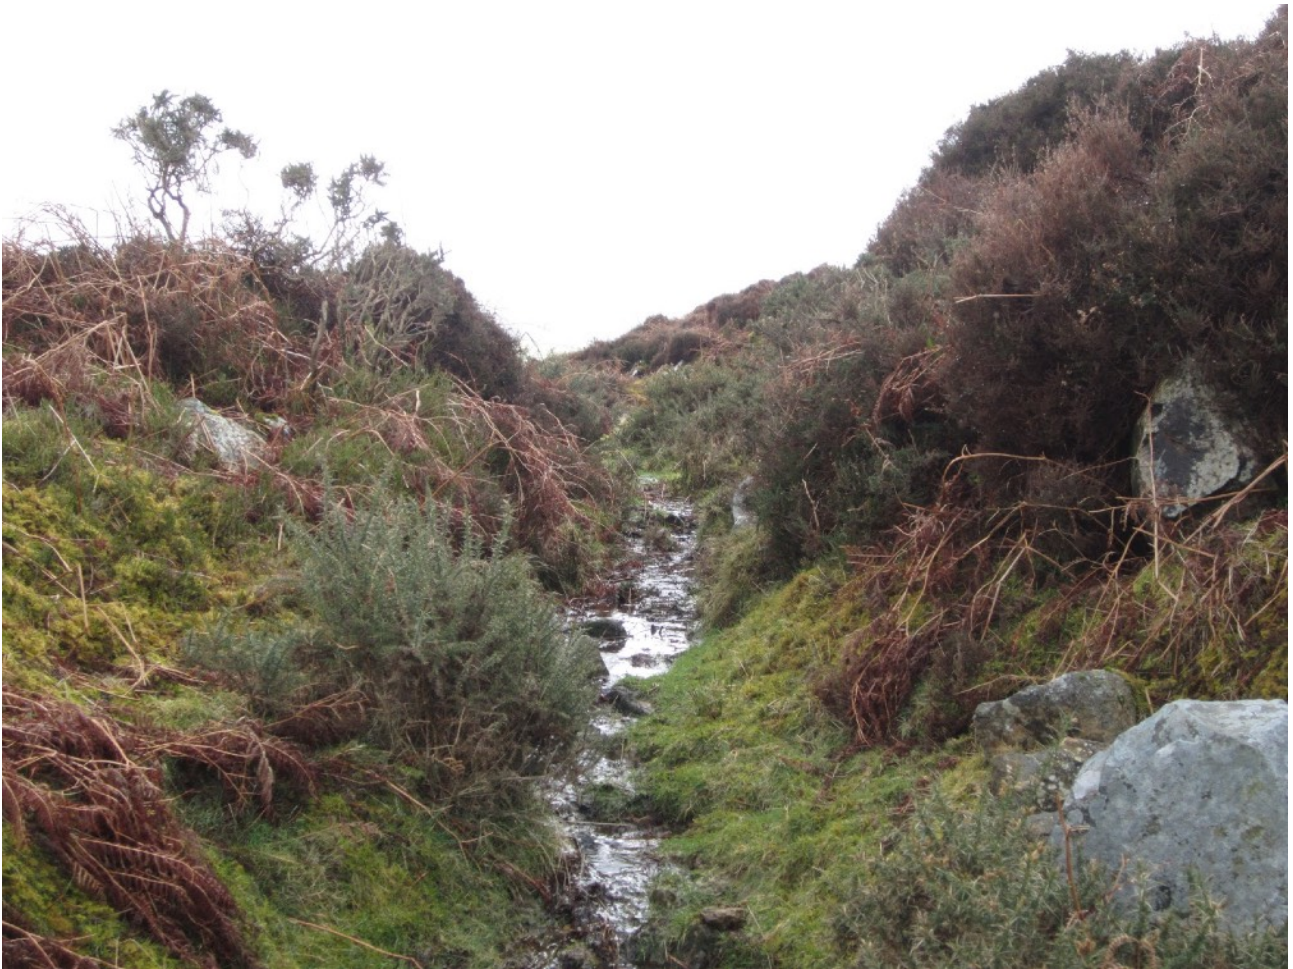
The entrance to the main quarrying area. This was wide enough to allow the passage of horses and carts, travelling from the quarry to the loading area adjacent to the cable drum pillars.

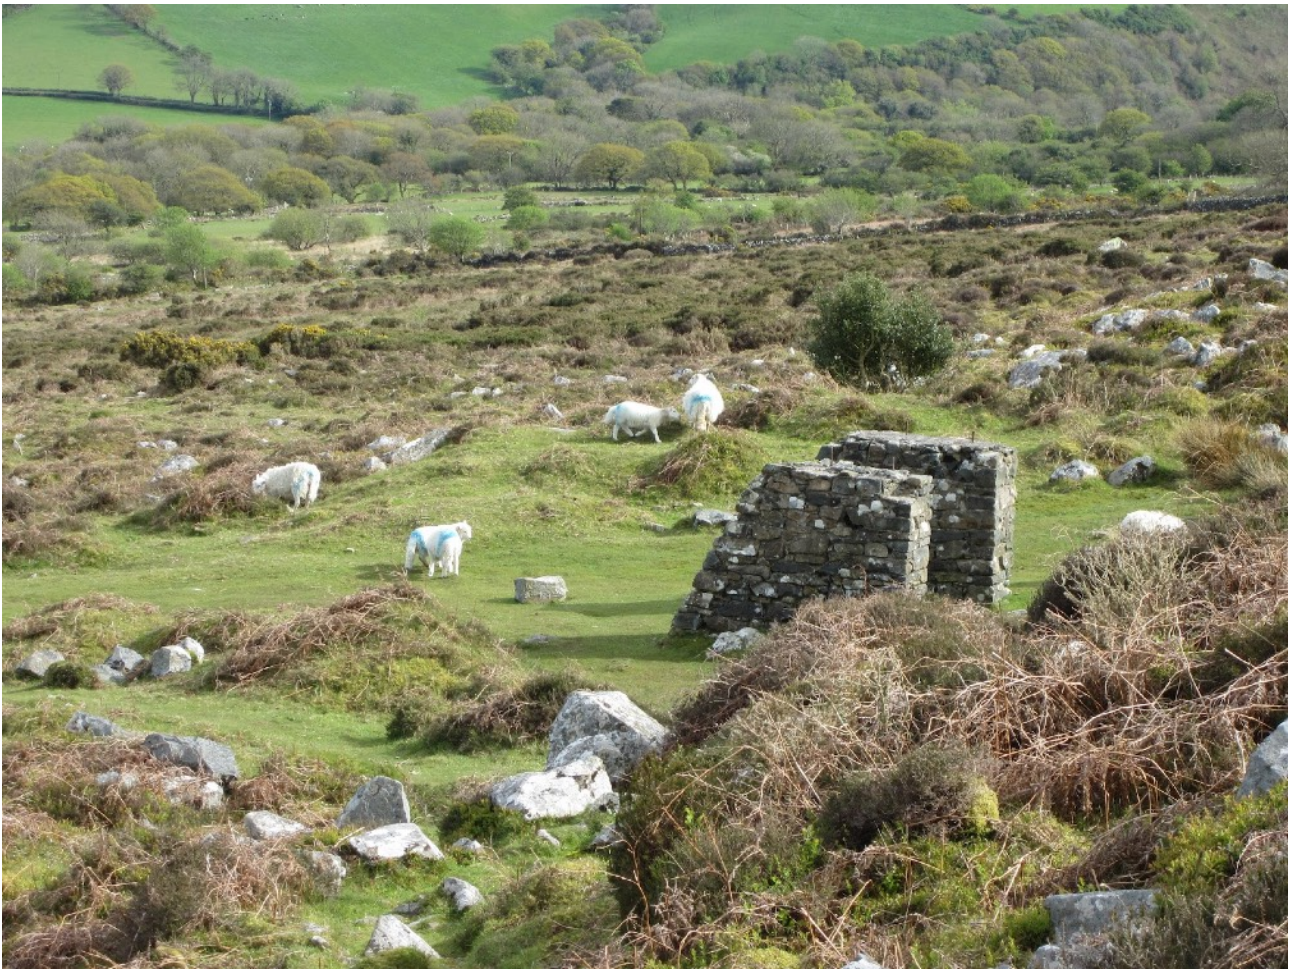
Another view of the pillars at the top of the incline, which mystify most visitors who know nothing of the railway and the quarry.....

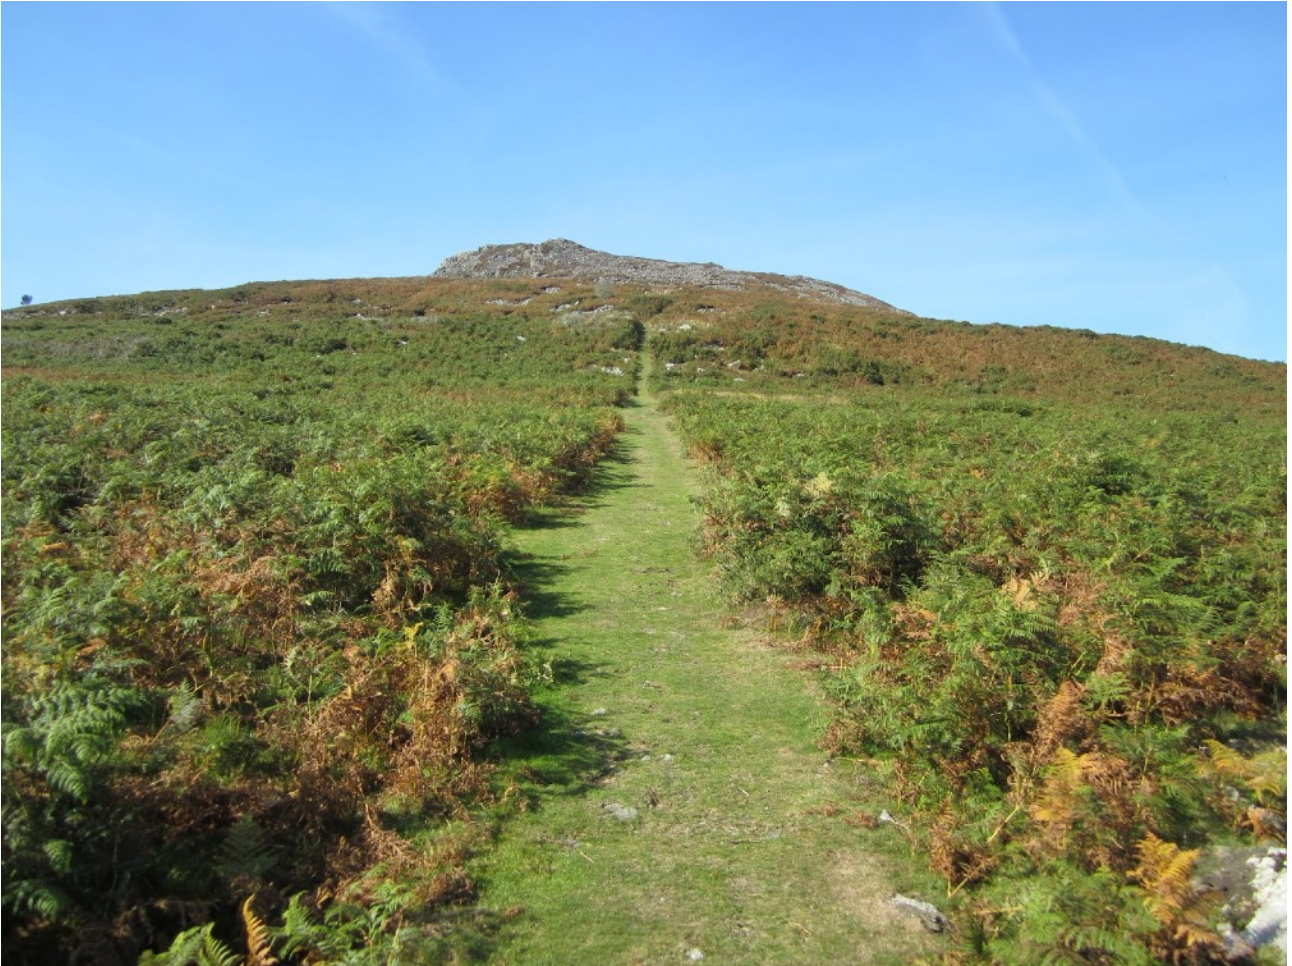
*Looking up the incline from the car parking area on the Dolrannog Road.
Mostly this utilises the natural slope, but there are some cuttings and
embankments.*

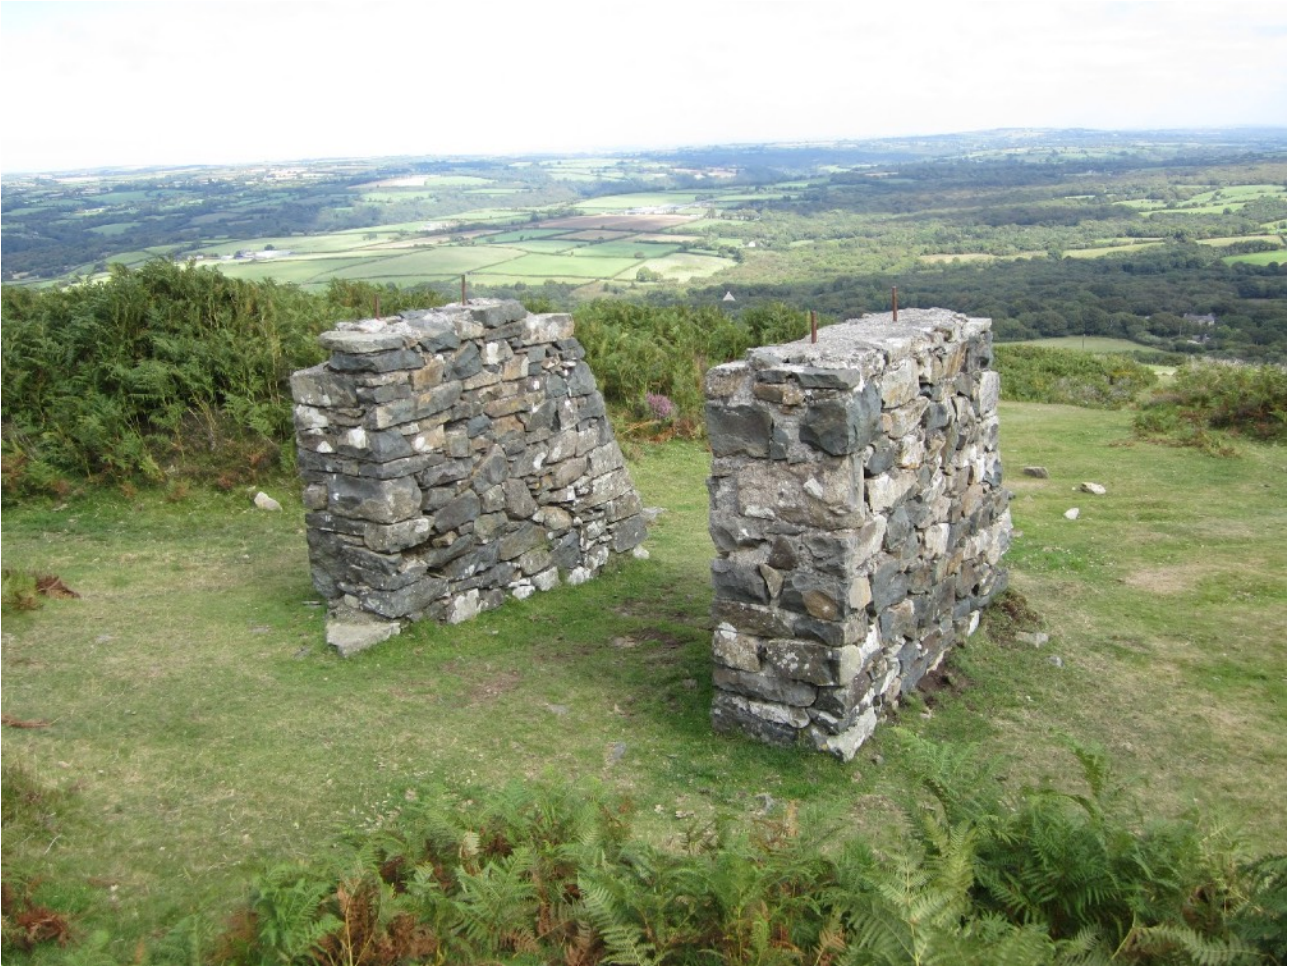
The cable drum pillars, showing the rather crude stonework. A diesel engine was set next to one of the pillars, and this operated the cable drum which allowed the loaded wagons to descend the incline to the crushing plant on the Cilgwyn Road under control, and then to be pulled back up again.

They set up in business, and built a narrow-gauge railway track about 500 yards long from the Cilgwyn Road up onto the mountain side. It runs almost east-west. In some places the men had to build embankments, and in others they had to excavate cuttings. They built a small crushing plant at the roadside, operated by a diesel engine. At the top of the incline they constructed two masonry pillars to support a large cable drum, the mountings for which were fixed on two large iron bolts on the top of each pillar. Another diesel engine was installed adjacent to the pillars, and this provided the power to rotate the drum and pull in the cable. They installed the railway track and bought three little railway trucks, which were connected together and then coupled to one end of the cable. When the trucks were stationed at the top of the incline they could be filled with blocks of stone carried from the quarrying area in a horse-drawn cart. Then they would be let down under the force of gravity, using a braking system on the cable drum to control the rate of descent. When they reached the

bottom, they would be unloaded and the stone fed into the crushing plant. Then the upper diesel motor would be started, and the cable would be wound in again, pulling the three trucks back up to the top of the incline for a fresh load of stone.

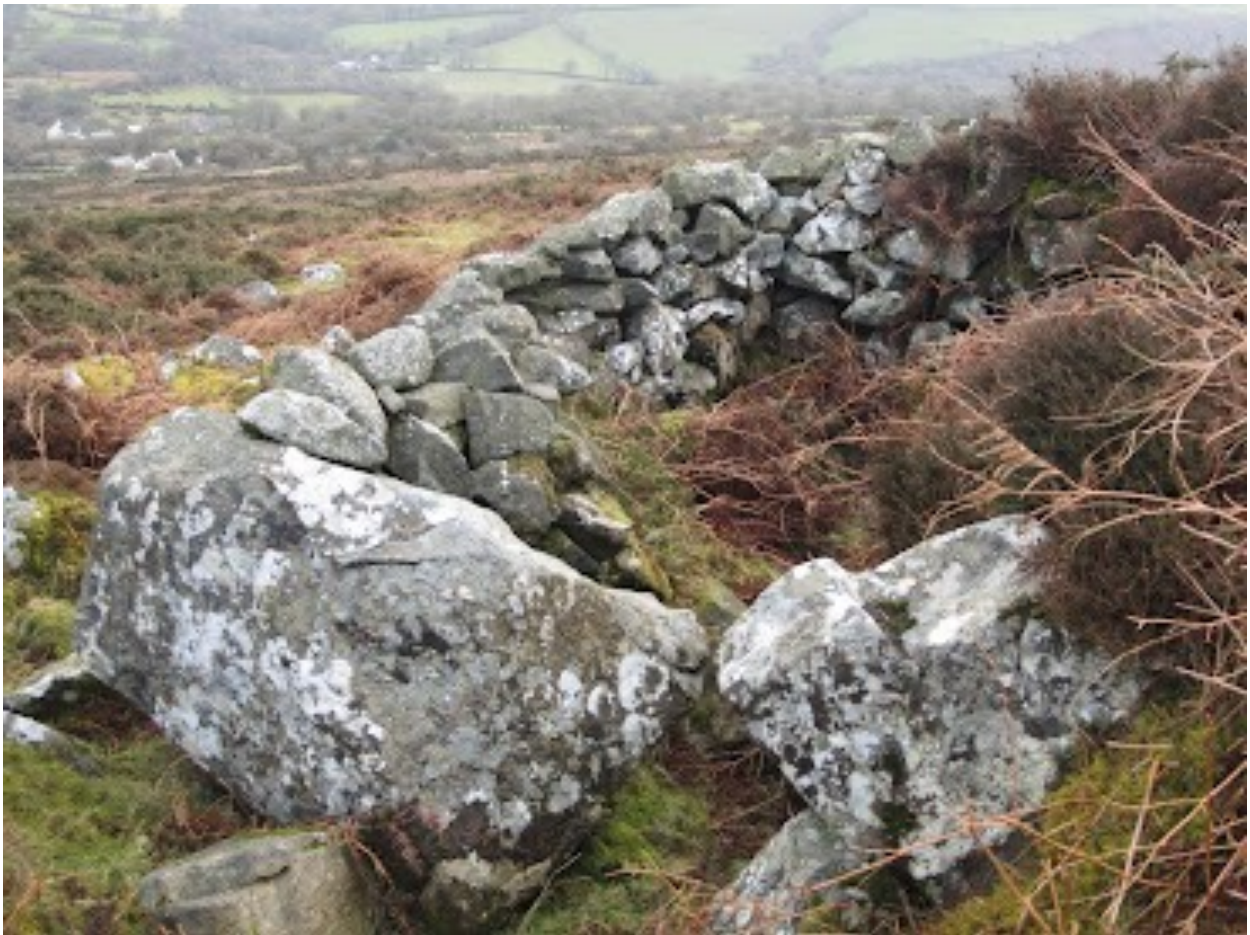
This is all that's left of the crude shelter used by the quarrymen in this exposed location in inclement weather..... it's very close to the stone pillars, just to the north of the top of the incline. It probably had a corrugated iron roof.
