**ARCHAEOLOGICAL EXCAVATIONS AT
THE SOUTH-WEST TOWER,
HEALTH CENTRE GROUNDS**

COWBRIDGE

Report 2010/07

**Client:
Cowbridge Charter Trust,
Town Walls sub-committee**

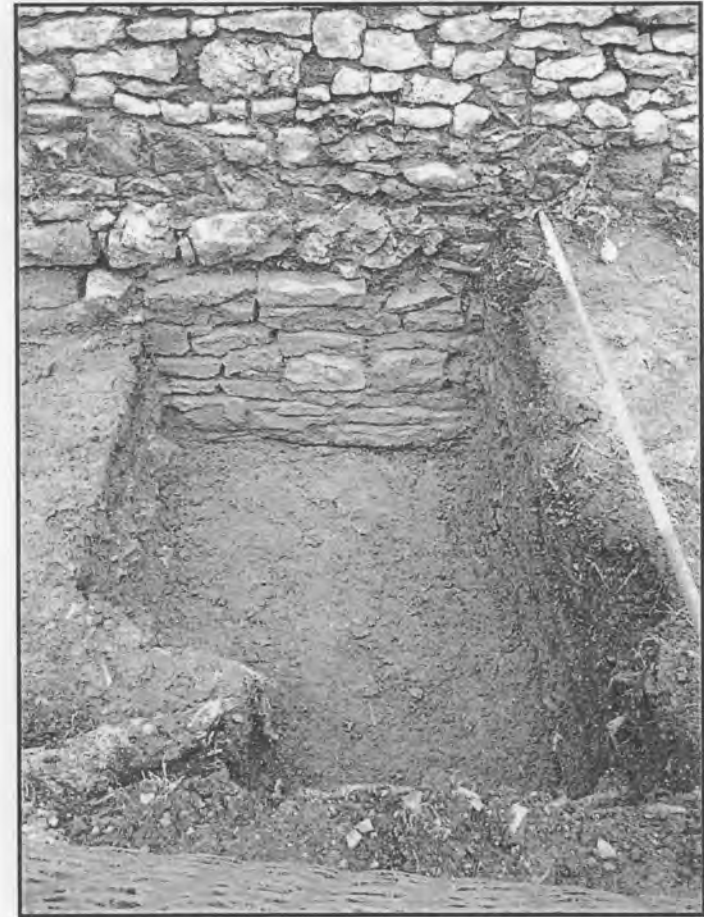
Plate 5: TP2, the medieval wall below
the 18th century wall from the north (CAC 2007, pl.16)

TP2 was excavated further along the same section of the wall (Figure 4) and clearly shows that the upstanding wall has been built on the remains of the medieval wall. The lower course of the wall is not tied in and a gap between the two walls is clearly visible (Plate 5). The stones of the modern wall are bonded with beige to light brown lime mortar in contrast to the clay-bonded medieval stonework. The difference in the quality of the stonework is also evident. A halfpenny of George III (1760-1820) probably issued in 1775 found in the construction layer 1 could indicate that the construction of the upstanding wall took place in the late 18th century. A residual rim sherd of a Roman amphora type Dressel 20 was discovered in the same context.

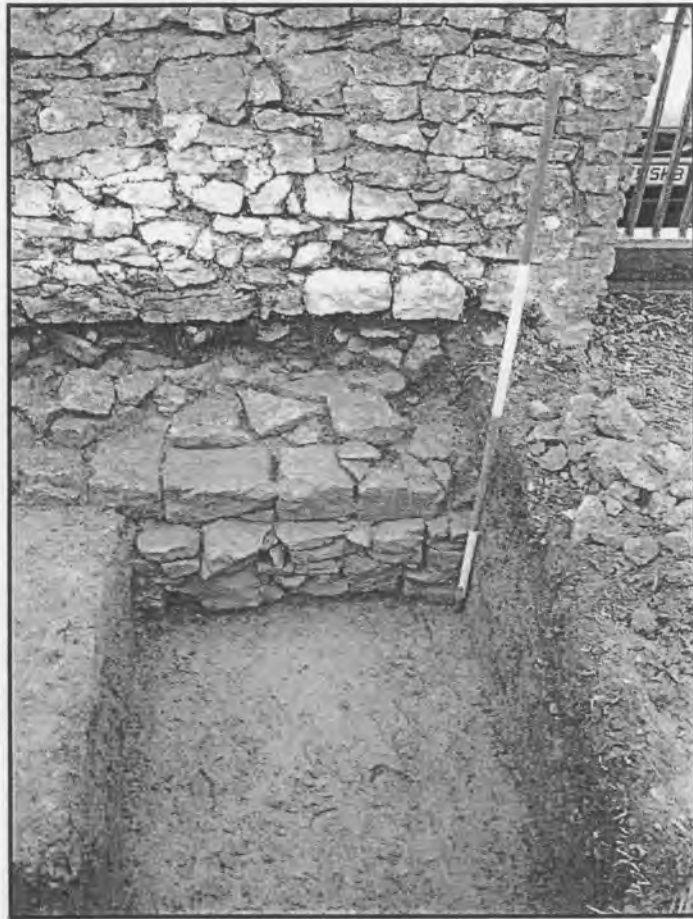
Plate 6: TP3, the medieval wall foundations below the upstanding wall from the north (CAC 2007, pl.18)

The result of the excavations of TP3 (Figure 4) confirms and completes the information from the two previous test pits. The same stratigraphical sequence is observed and the overlap of the two walls is even more evident (Plates 6 and 7). The fabric of the foundation of the medieval wall 03 is also similar to the one in test pit 2 and its base lies at a height of 28.14m OD. The position of the medieval wall, 0.50m to the north of the line of the later upstanding wall also clearly demonstrates that its line of the latter diverges from that of the original medieval wall. This also explains why the foundations of the medieval wall do not show below the wall 02, as they are in a recessed position due to the diverging lines of the walls.

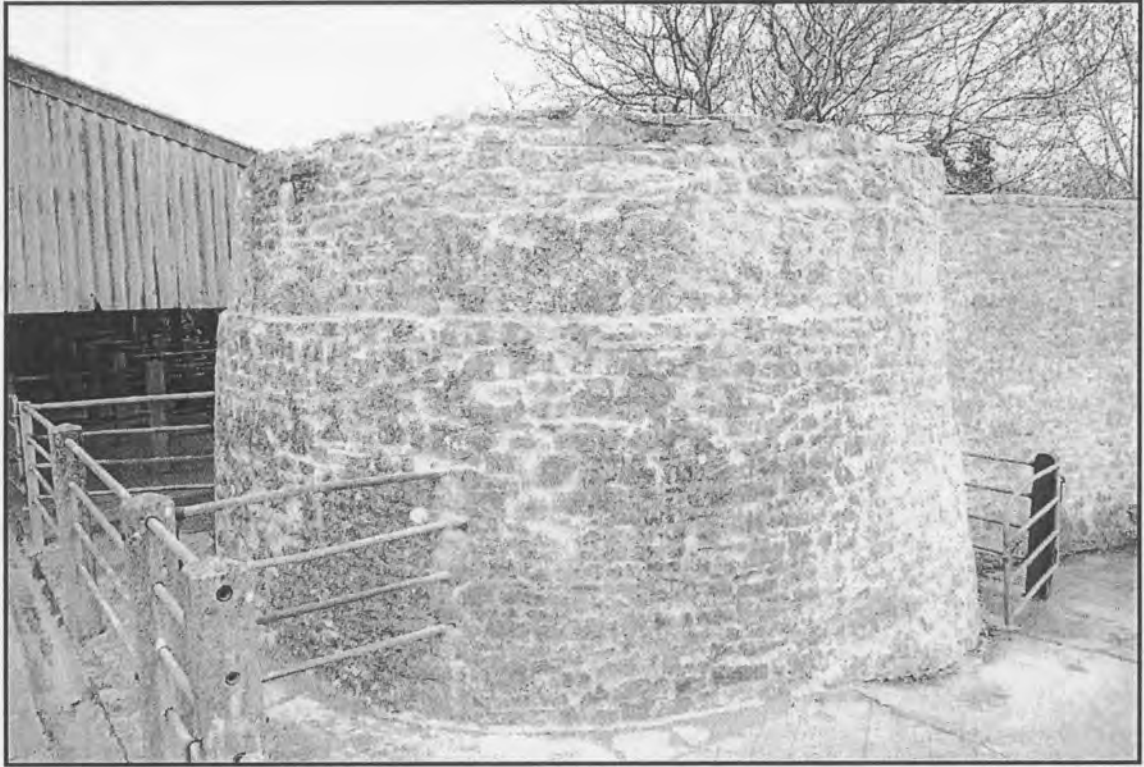
Plate 8: The south west tower and the summer-house from the south-west

In the 1999 appraisal of the walls, the battered lower section of the south-west tower was described as part of the original medieval defences with a polygonal 18th-century summer-house built on its upper course (Plate 8). The raised walkway or terrace constructed against its internal side was also noted and attributed by Spurgeon with the summer-house to a phase of landscaping of the grounds of Old Hall (Spurgeon 2001, 186), residence of the Edmondson family.

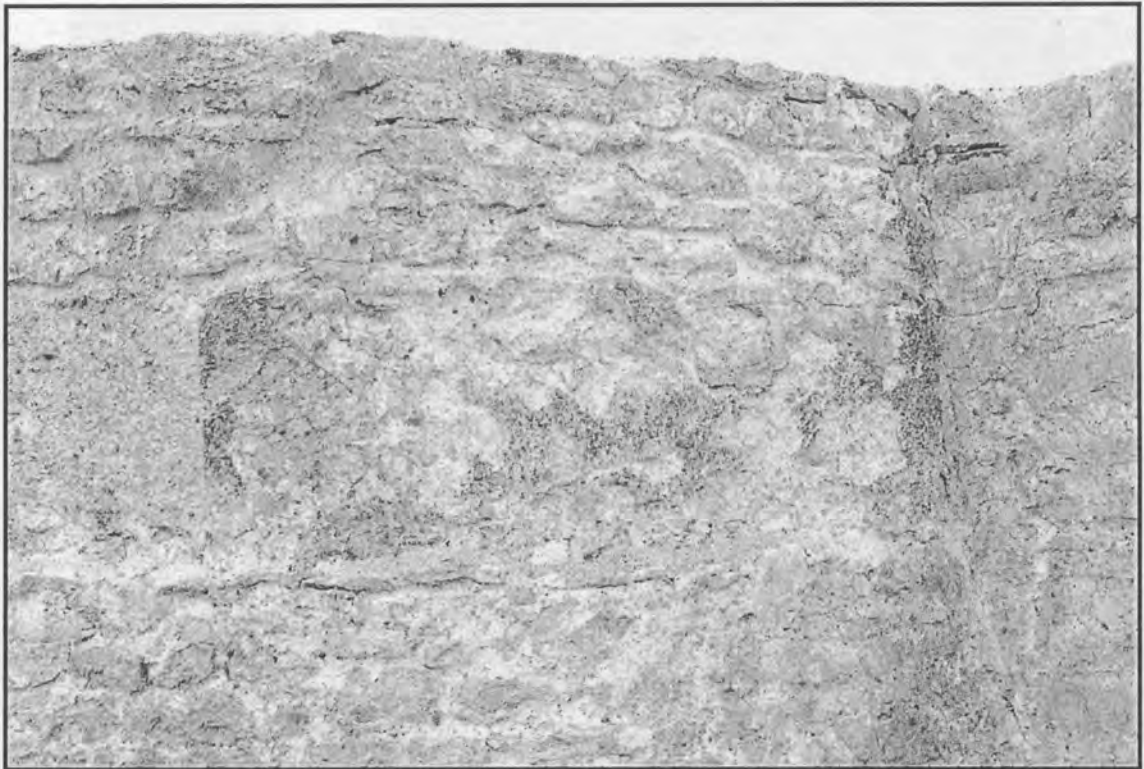
Plate 9: Remains of the gravel render on the external summer-house wall from the east

After removal of the over-grown vegetation in and around the south-west tower, the plan of the polygonal summer-house (01) became evident (Figure 6). Nine narrow walls 0.54m wide rest recessed on the base of the medieval tower (Figure 7). A fireplace is set in the western wall and was flanked by two openings of which the southern one had been blocked. The walls were constructed coursed limestone rubble bonded with a lime mortar and survived to a height of 1.10m. The external face still shows patches of the original calcite gravel render (Plate 9) noted by Spurgeon (Spurgeon 2001, 186). Two sections in the south and north sides have probably been rebuilt and are also recessed in the original summer-house wall (Plate 10). Several repointing phases were also noted on the internal stonework.

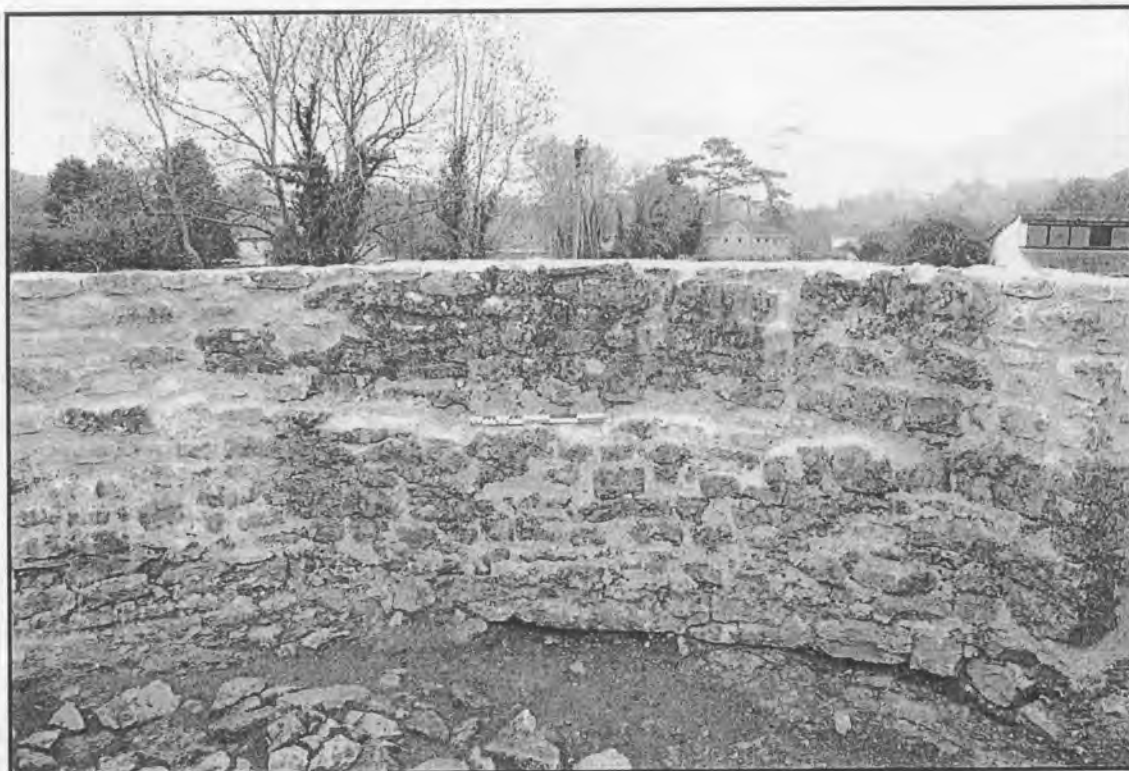
Plate 10: Repaired section in the eastern summer-house wall from the east

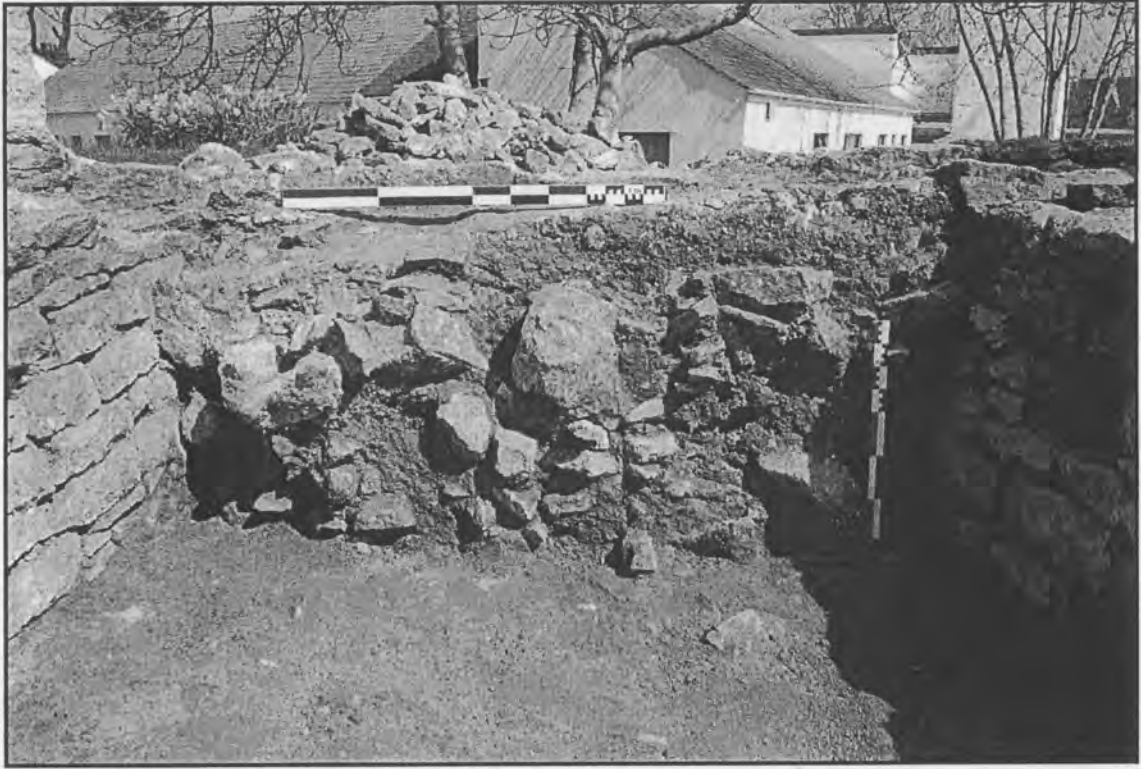
Plate12: The fill 06 in the south-west tower from the west

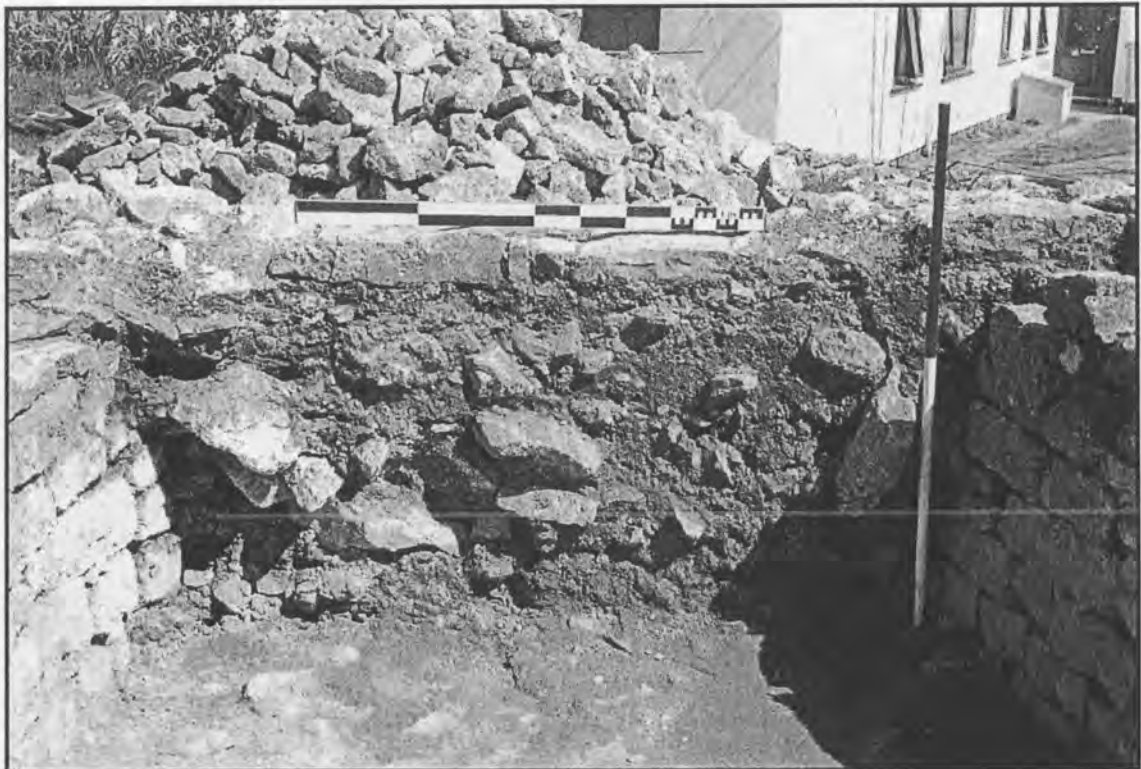
Plate 13: The summer-house wall 01 above the fill 06 from the west

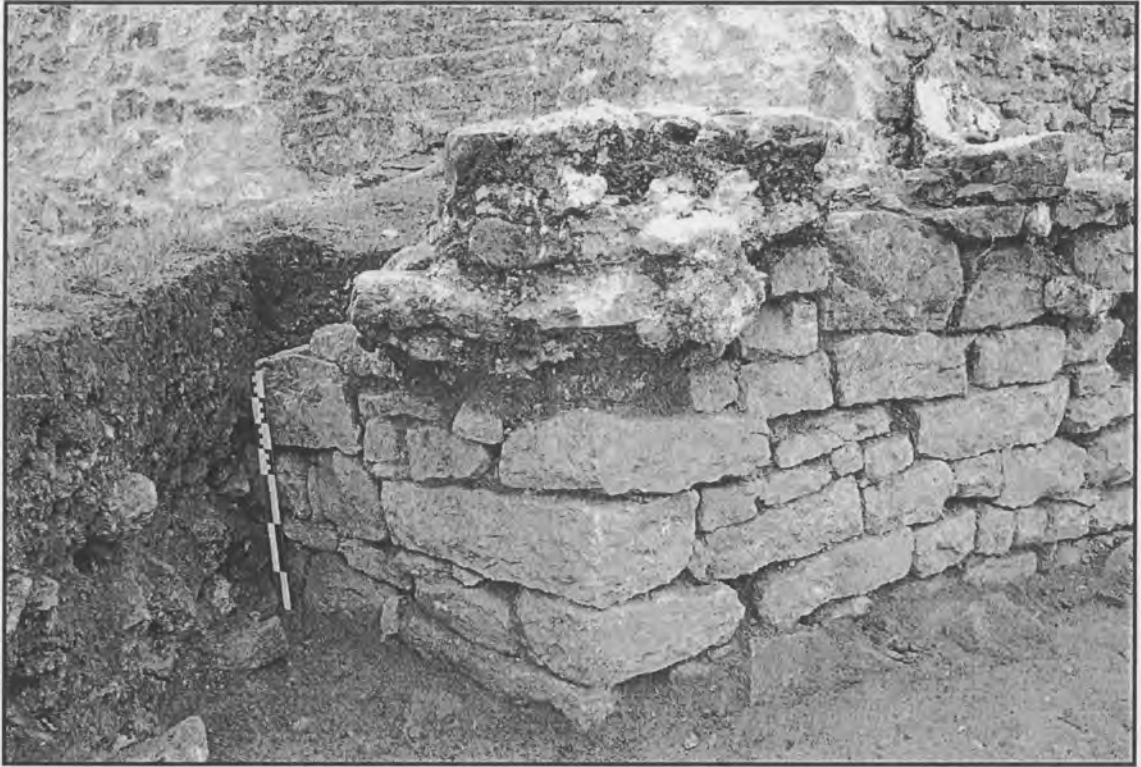
Plate 16: South-east corner of the tower from the north

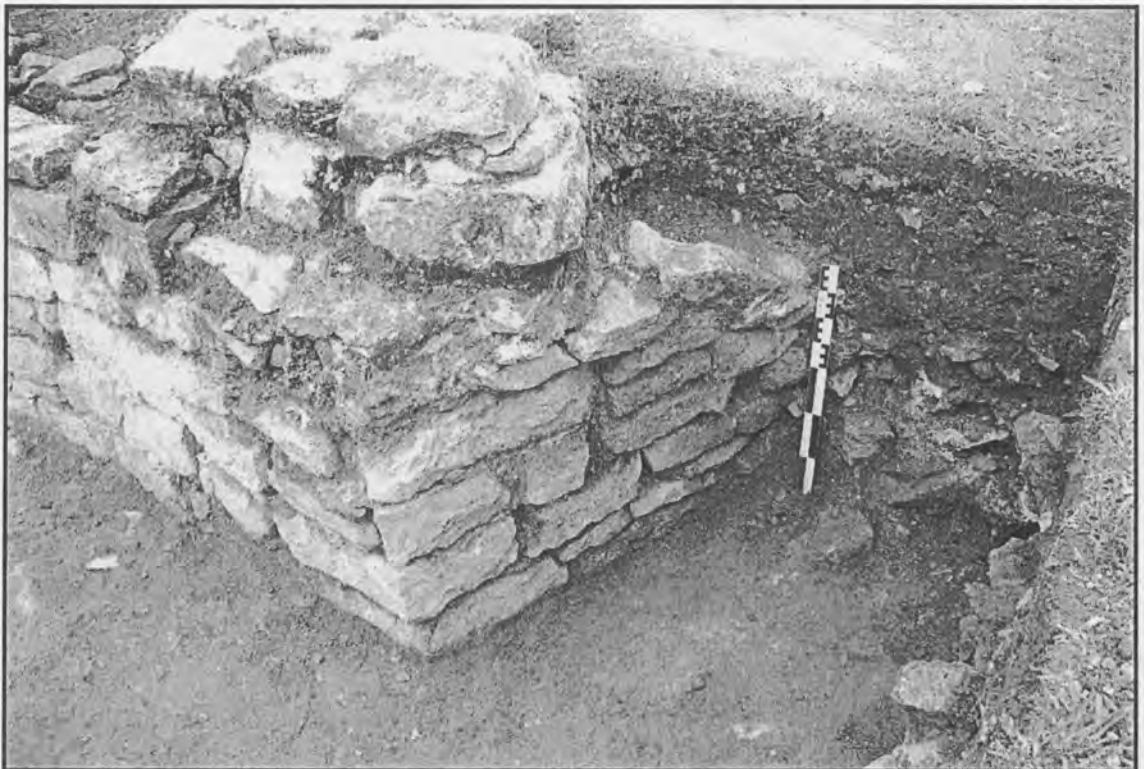
Plate 17: North-east corner of the tower from the south

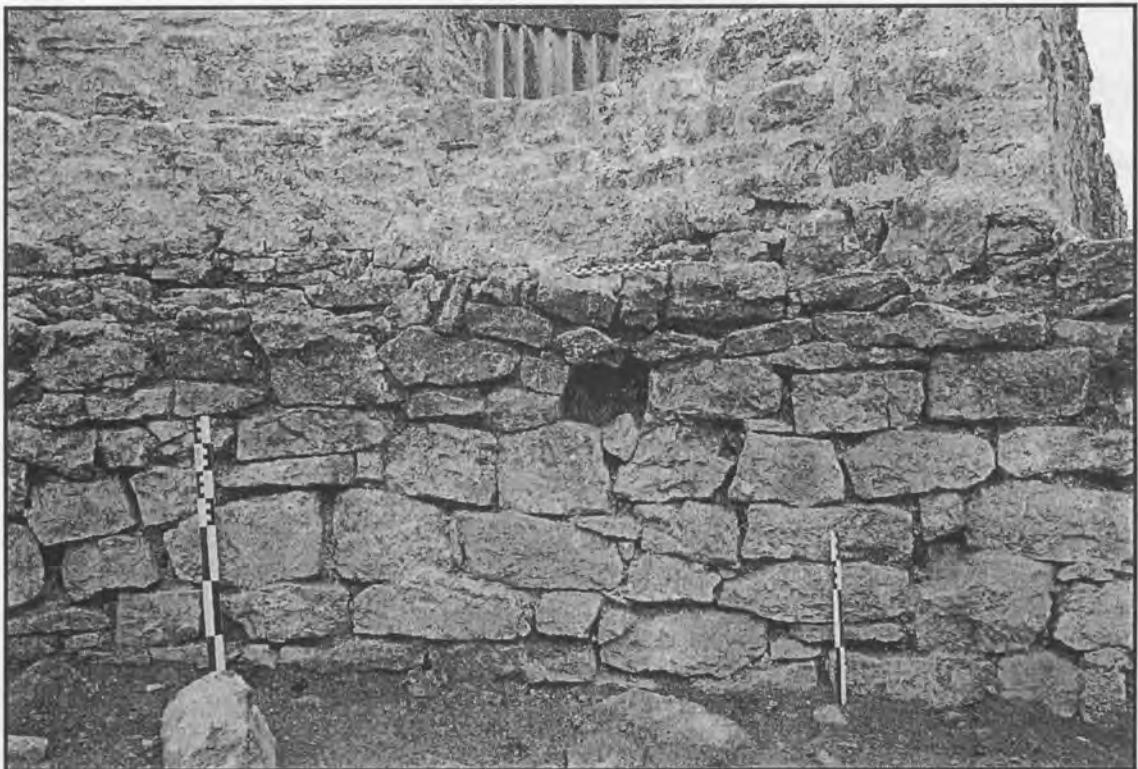
Plate 19: the northern revetment wall in the tower from the south

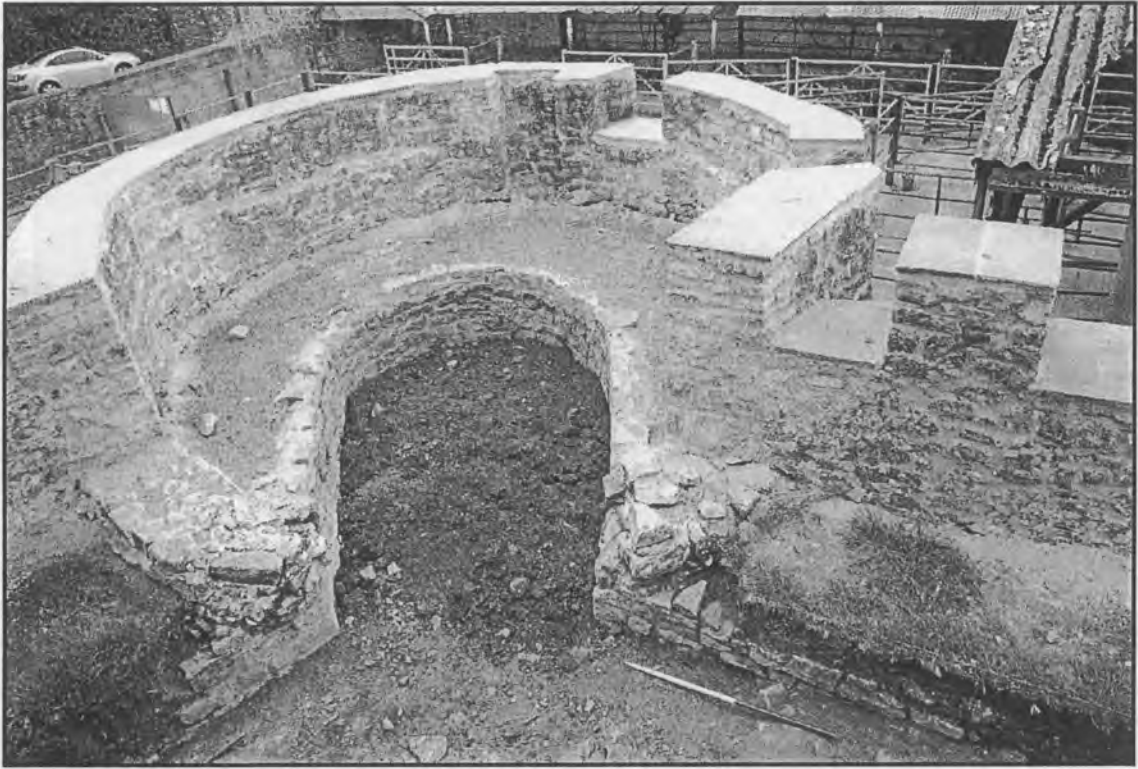
Plate 20: The south and north-west sections of the medieval wall from the east

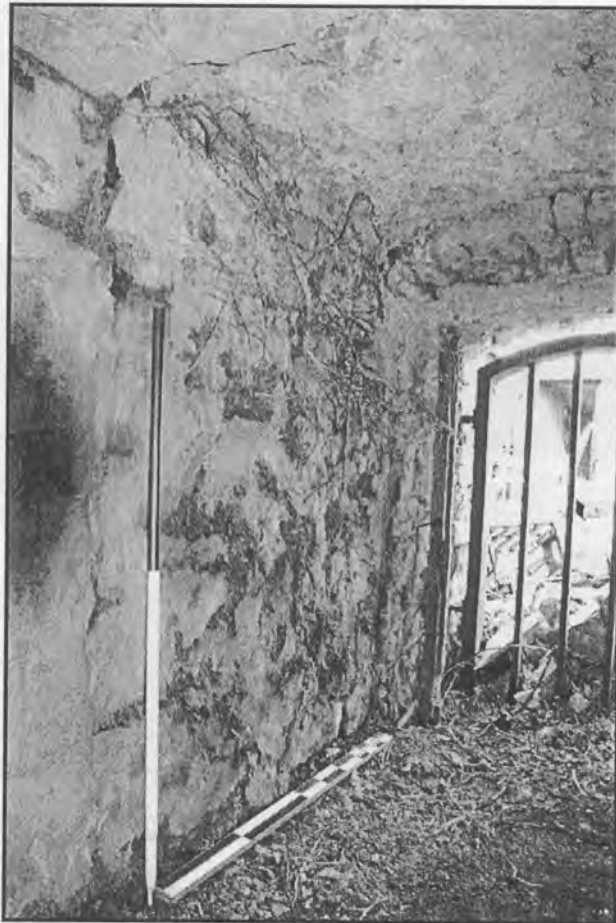
Plate 23: The medieval wall in the northern passage below the raised walkway

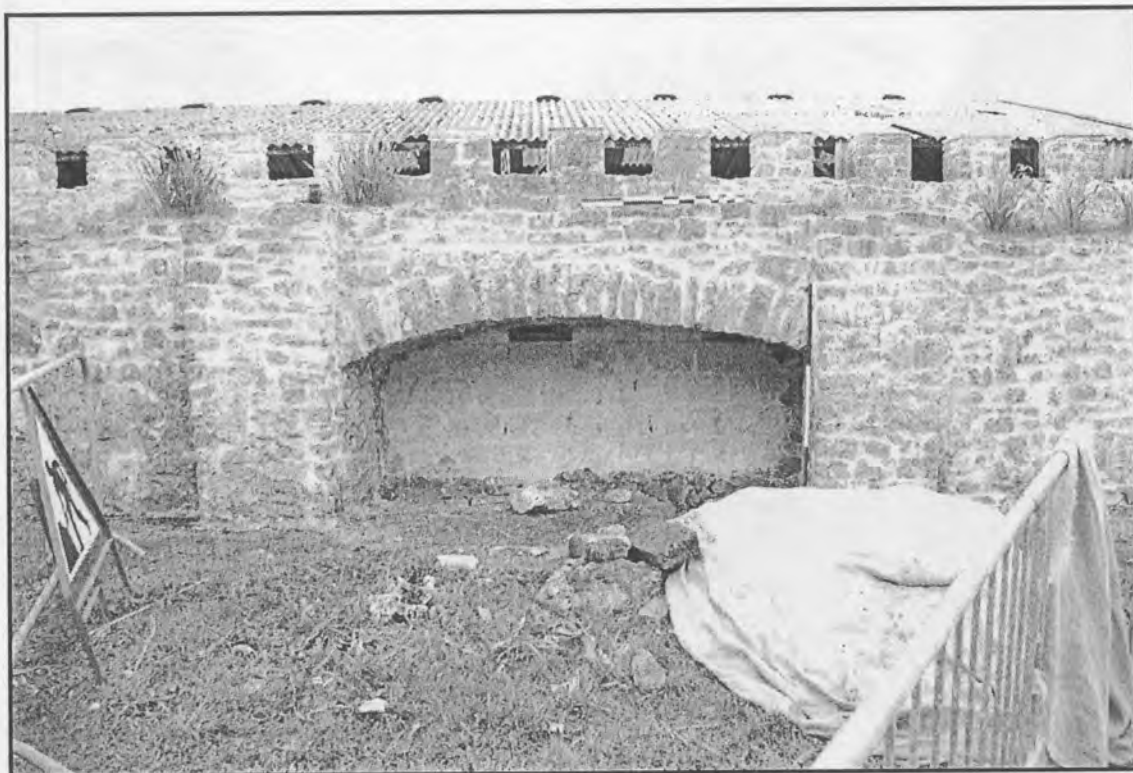
Plate 24: The passage from the east

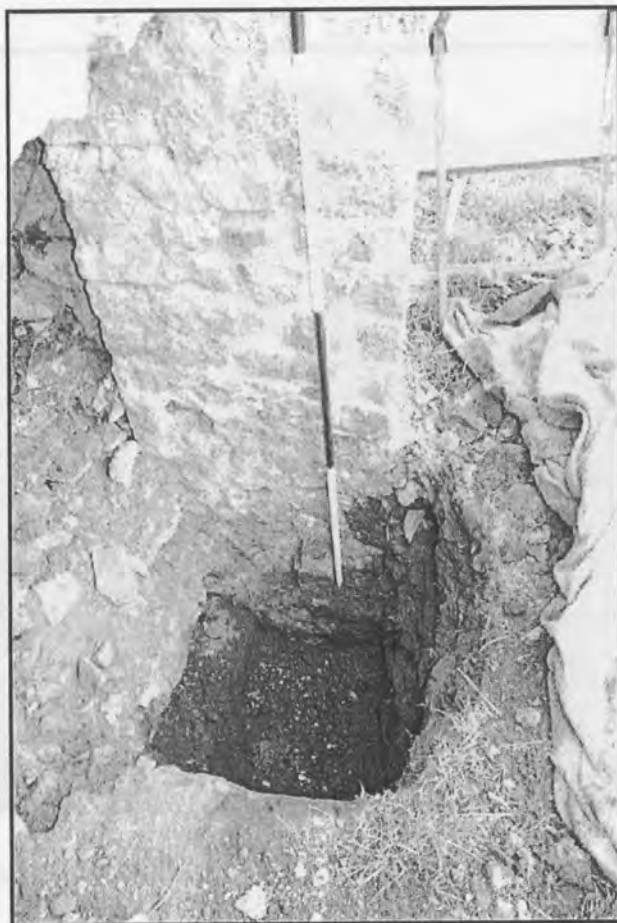
Plate 25: The test pit from the south

A small test pit 0.80m x 0.90m was hand excavated at the base of the northern pillar. Below the topsoil (00) a thick layer of black soil with recent building rubble (12) is recorded to the top of the pillar's footings (Figure 16, section 06, Plate 25). Below this a 0.36m thick of fine black soil (13) was recorded and interpreted as buried topsoil. The nature and recent date of the building rubble found in the upper layer 12 and the breeze block wall obstructing the passage indicate that it was probably blocked and the ground level raised during the construction of the Health Centre in 1973-74 (Newman 1995, 333).

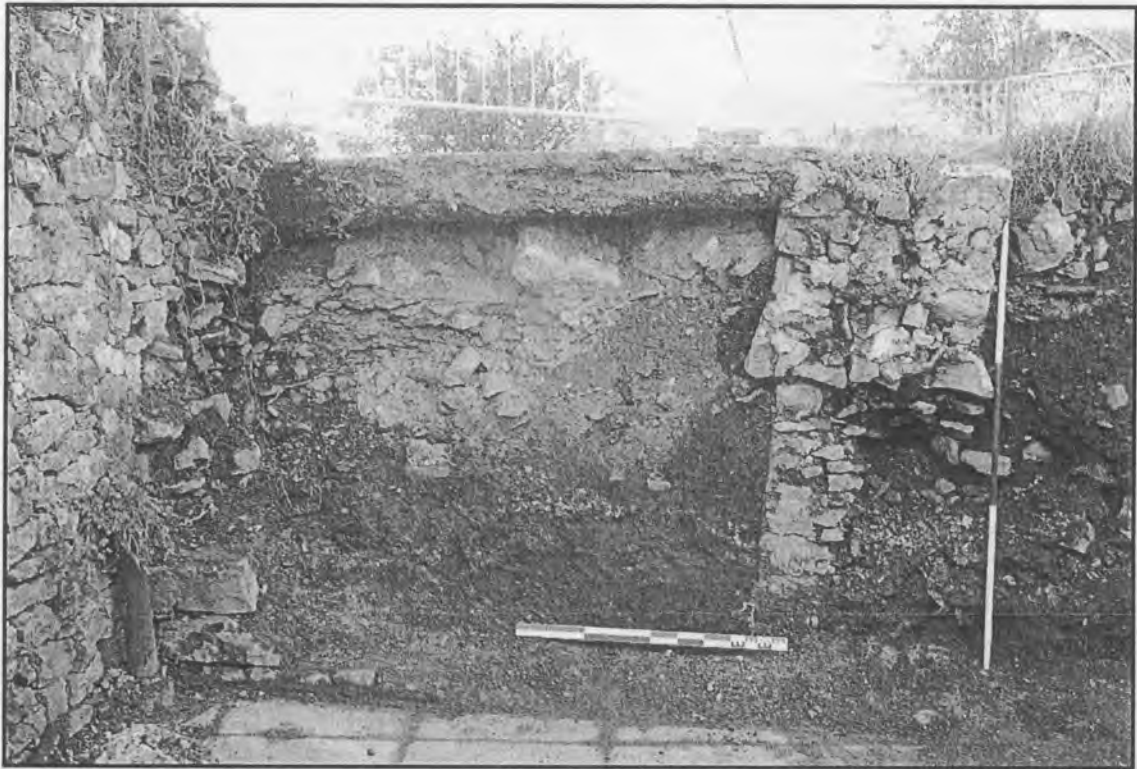
Plate 26: The retaining wall of the raised walkway from the north

The structure of the raised walkway with its retaining wall (23/24) and its brown soil and stones fill (26) was clearly identified (Plate 26). The upper section of eastern retaining wall 24 was partly rebuilt from both side (25) and the same white lime mortar (21) used to re-establish the level. It is likely that this took place in recent times during the construction or refurbishment of the flight of steps leading to the north end of the raised walkway. Wall 29 with its cement mortar was the remains of another modern repair to the boundary wall.

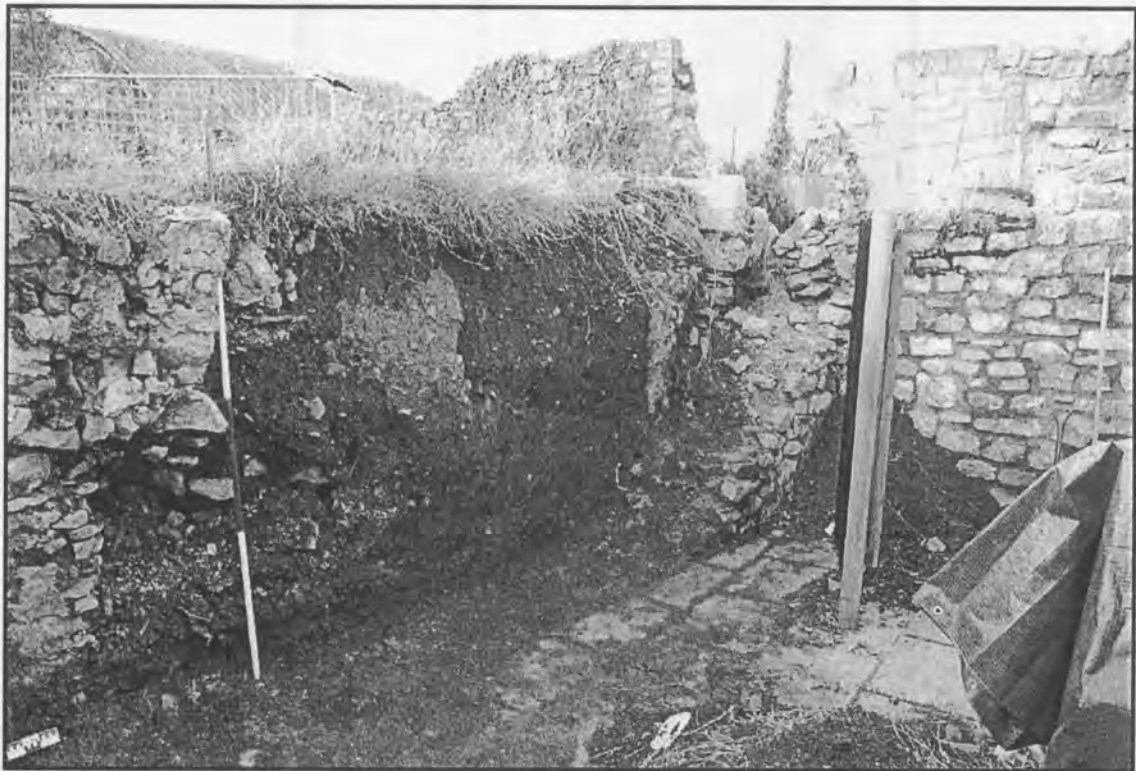
Plate 27: The medieval wall behind the boundary wall 28 from the north-east

7.4 The section recorded behind the boundary wall at the north end of the raised walkway only serves to confirm that a large section of the medieval wall has been preserved below the raised walkway and was perhaps in a better state of repair than the south wall. It also shows that the continuation of the wall to the north is not original and that only the lower courses or the foundations have been preserved below the former Masons Arms yard floor or maybe in the building itself.
